Hatteras Breach, North Carolina

by Ty V. Wamsley, Kent K. Hathaway, and Michael Wutkowski

PURPOSE: This Coastal and Hydraulics Engineering Technical Note (CHETN) is intended to document the rapid response of the U.S. Army Corps of Engineers to engineer and construct a breach closure and the lessons learned. The note also documents the short-term morphologic evolution and hydrodynamic characteristics of the breach based on an analysis of collected data. Researchers are utilizing this important data set in the development of numerical models of coastal breaching and to further the Corps' understanding of the breaching process.

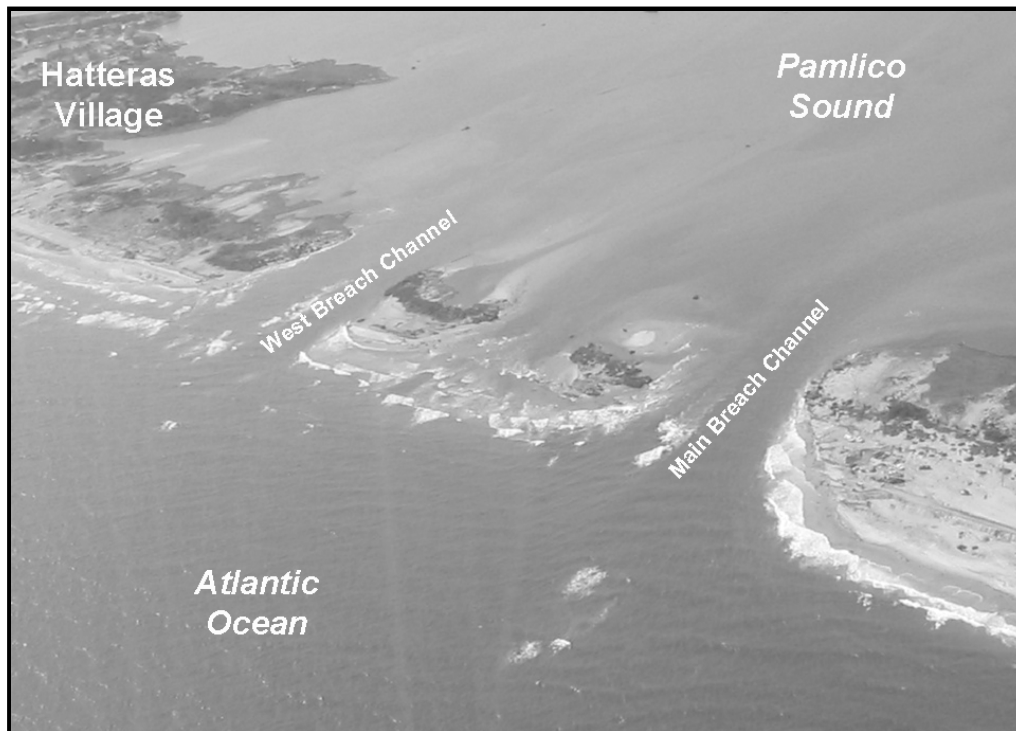
Figure 2. Hatteras breach, 22 September 2003.

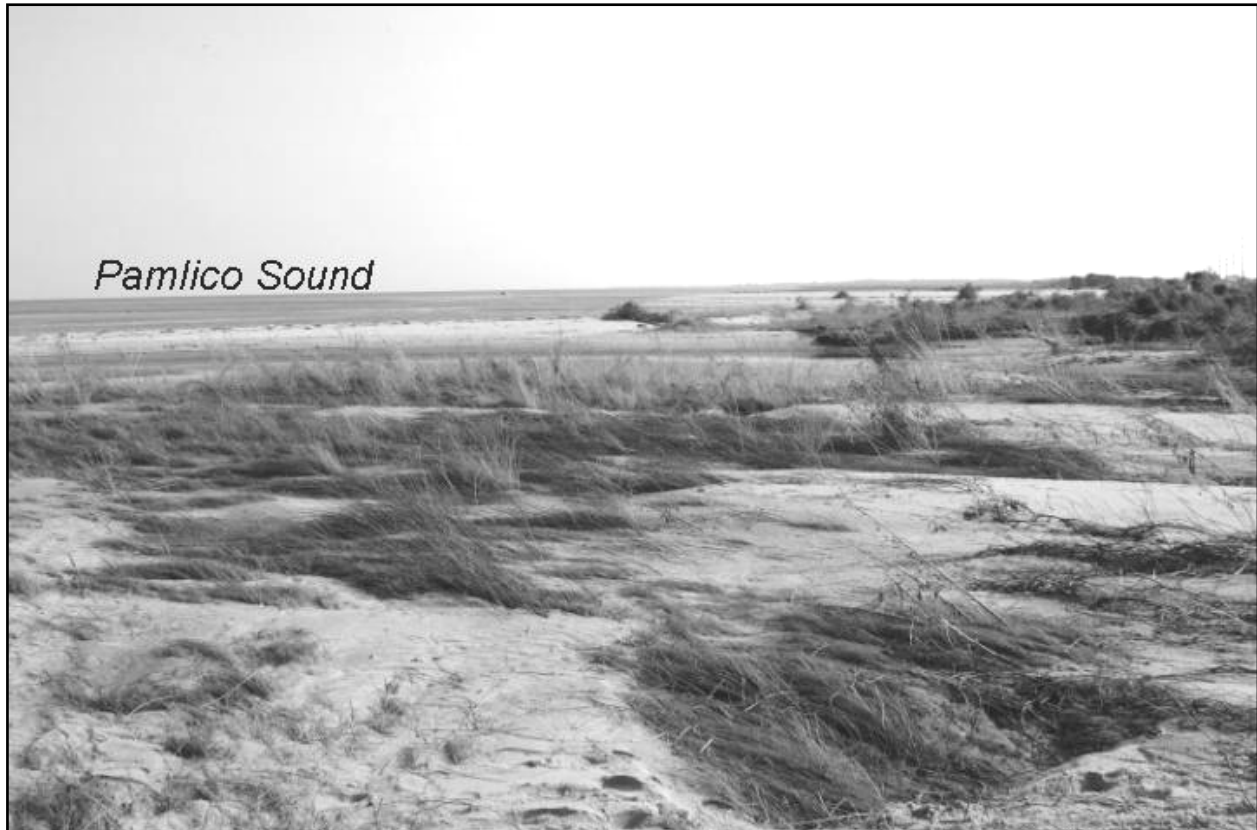
The narrowing and lowering of Hatteras Island at this location weakened the barrier and subjected it to breaching. Evidence of powerful overtopping water flow was observed at the breach. Brush and other vegetation adjacent to the breach channels were matted and flattened toward the Pamlico Sound by overwashing flow (Figure 3). Channelization at the lowest points in the barrier scoured the breach channels.

Figure 3. Matted vegetation flattened toward Pamlico Sound by strong overwashing flow.

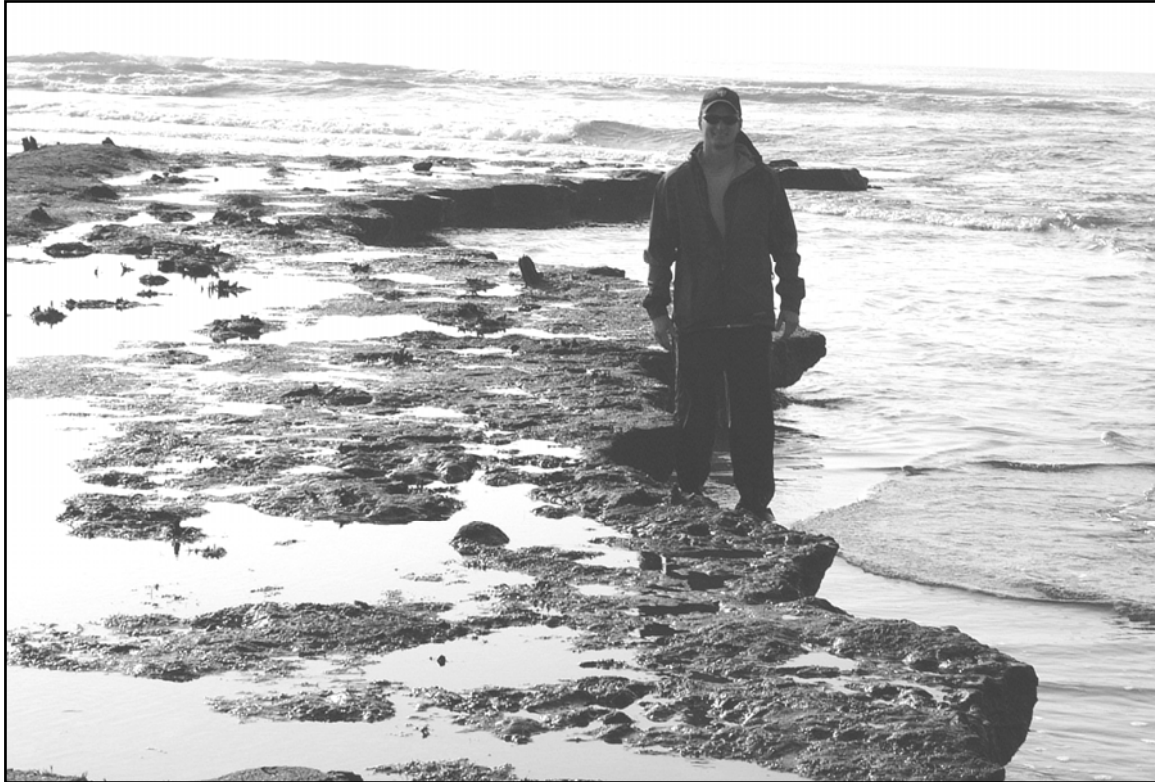
Figure 4. Western edge of peat terrace, looking southeast. Peat extends approximately 1.5 to 2 ft above the adjacent sandy bottom.

The peat terrace restricted flow in the middle breach channel, which was about 225 ft wide. Water flowed through the middle channel and over the peat terrace only at higher tide elevations. The restricted flow resulted in little scour of this channel. Maximum depths in the middle channel were about 5 ft NAVD88 (1988 North American Vertical Datum). The west channel was about 350 ft wide and littered with debris (Figure 6). Pilings from the bridge partially constructed in the 1930s extended across the channel on the ocean side. Large chunks of asphalt and roadbed material were visible at lower tide elevations, particularly on the west side of the channel. Near the center of the channel was a peat outcropping with large chunks of asphalt resting on top. The flow through the west channel was somewhat greater than that of the middle channel. Survey 2 maximum depths in the west channel were 7 to 10 ft NAVD88. The eastern-most breach channel was approximately 325 ft wide on the sound side and 350 ft wide on the ocean side and was the main channel as it captured a majority of the tidal prism. The unrestricted flow through this channel created scour depths down to 20 ft NAVD88.

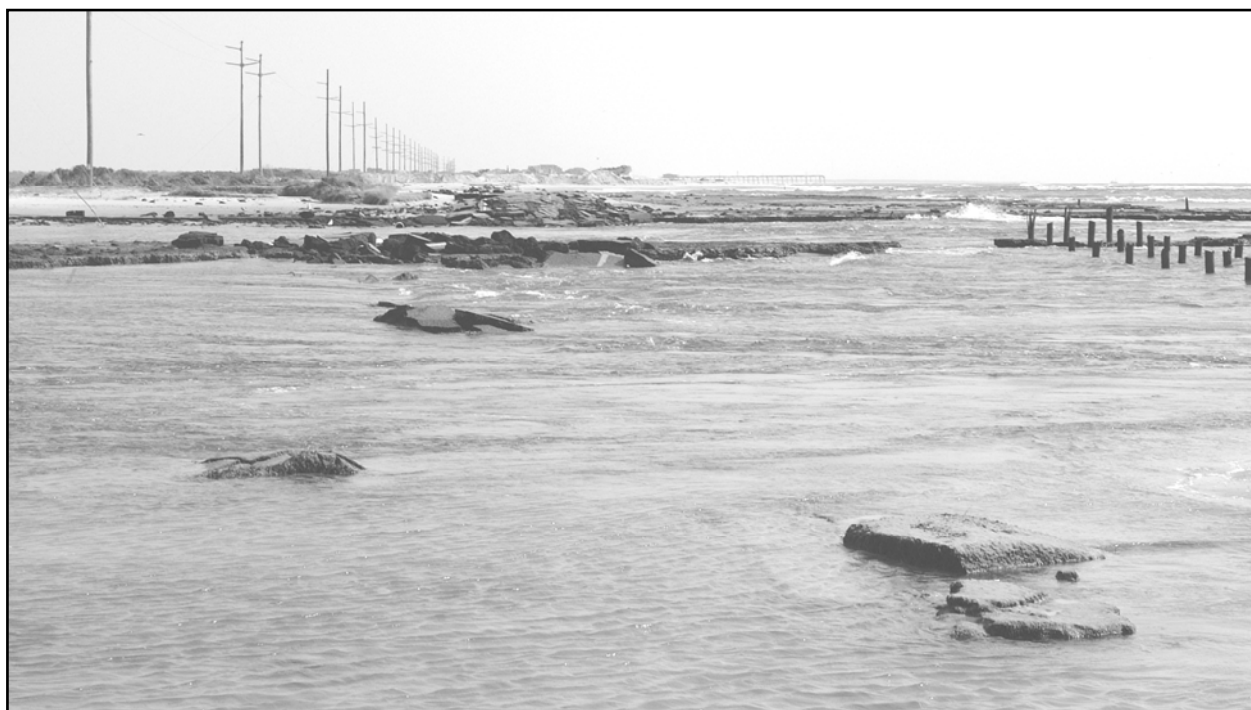
Figure 6. West breach channel, looking east, 5 October 2003. Note old bridge pilings on right and extensive road debris in channel.

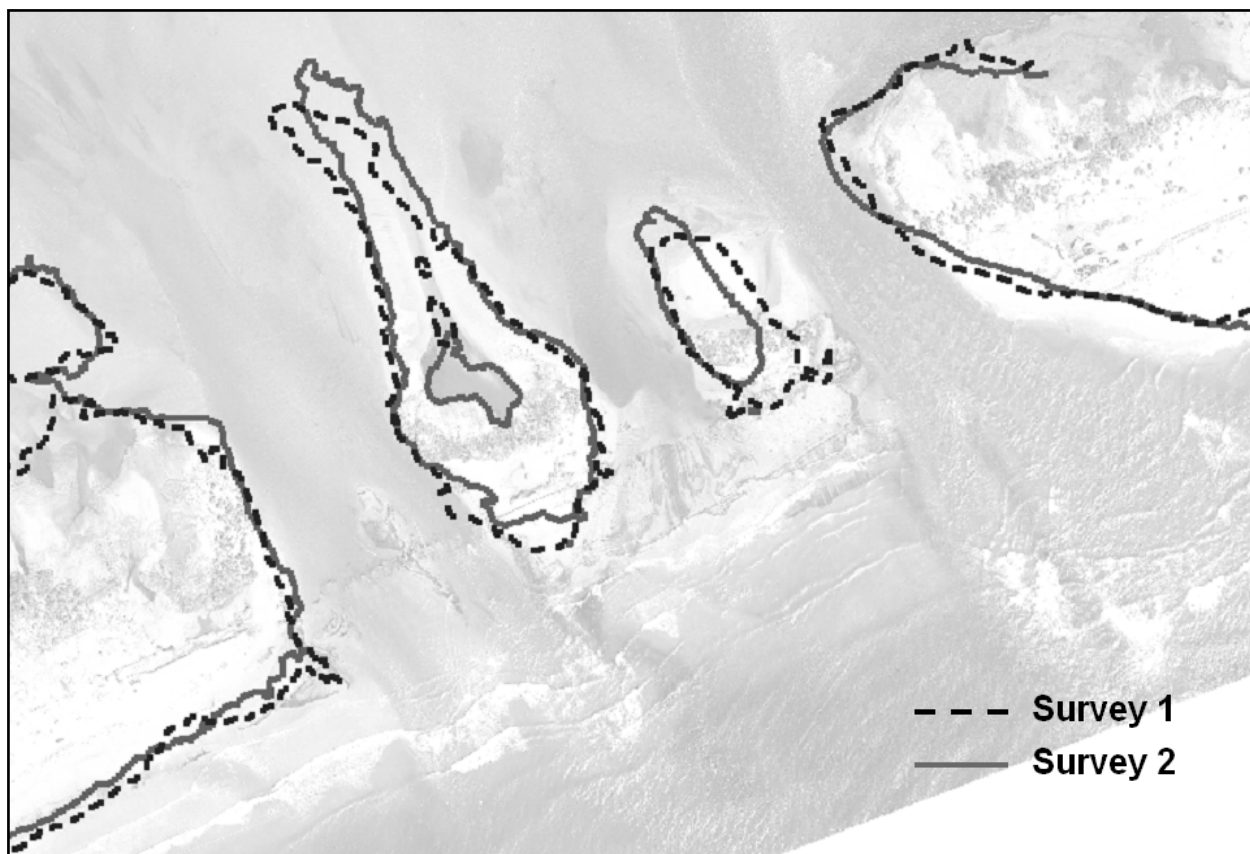
Figure 8 is a comparison of the 0-contour (NAVD88) between Surveys 1 and 2. The recession of both channel banks at the ocean end of the breach is evident. The east bank receded 25 to 45 ft while the west bank moved 40 to 80 ft. On the sound end of the breach channel, the east bank advanced approximately 25 ft, pushing the channel to the west. This end of the channel also continued to widen, however, as the west bank receded about 45 ft.

Figure 8. Comparison of the 0-contour (NAVD88). Aerial photograph was taken on 24 September, tide elevation -1.3 ft NAVD88 (NCDOT photograph).

Figure 8 illustrates the elongation of the margin shoals behind both breach islands. The east island shoal advanced approximately 65 ft. The west island shoal migrated in a northerly direction and also elongated by approximately 65 ft. The 0-contour on the front side of each island receded. This recession, however, was not from erosion of the peat terrace. The peat terrace elevation was below 0 NAVD88, and the sandy material on top eroded during higher tide elevations.

Figure 8 also shows beach shoreline change within about 500 ft of the breach. On the west side, the beach eroded approximately 35 ft. Sediment supplied by longshore transport advanced the

shoreline to the east by as much as 55 ft within about 425 ft of the breach channel. The beach tended toward erosion at greater distances from the breach.

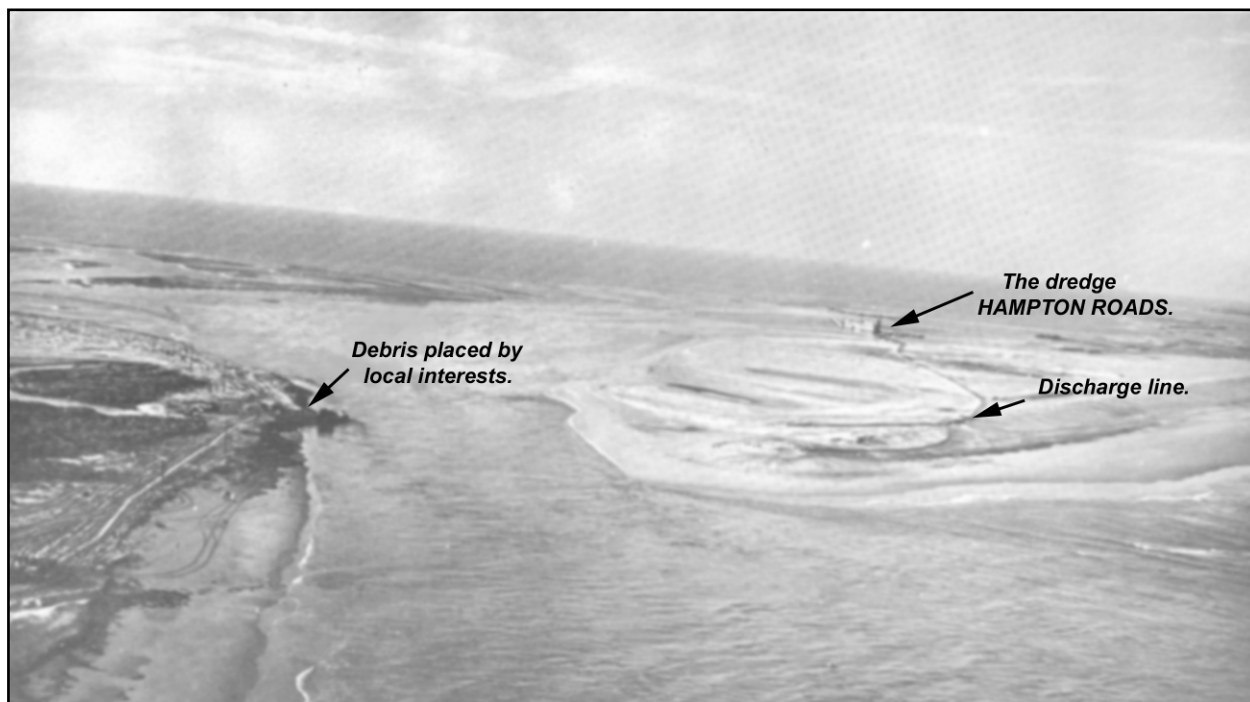
Figure 13. Buxton Inlet, 29 January 1963, looking towards sound.

The closure of Buxton Inlet demonstrated that the Hatteras breach could be closed by discharging dredged material into the breach without additional measures, such as the sheet-pile dike used in the closure of the breach on the south shore of Long Island, NY, at Moriches Inlet

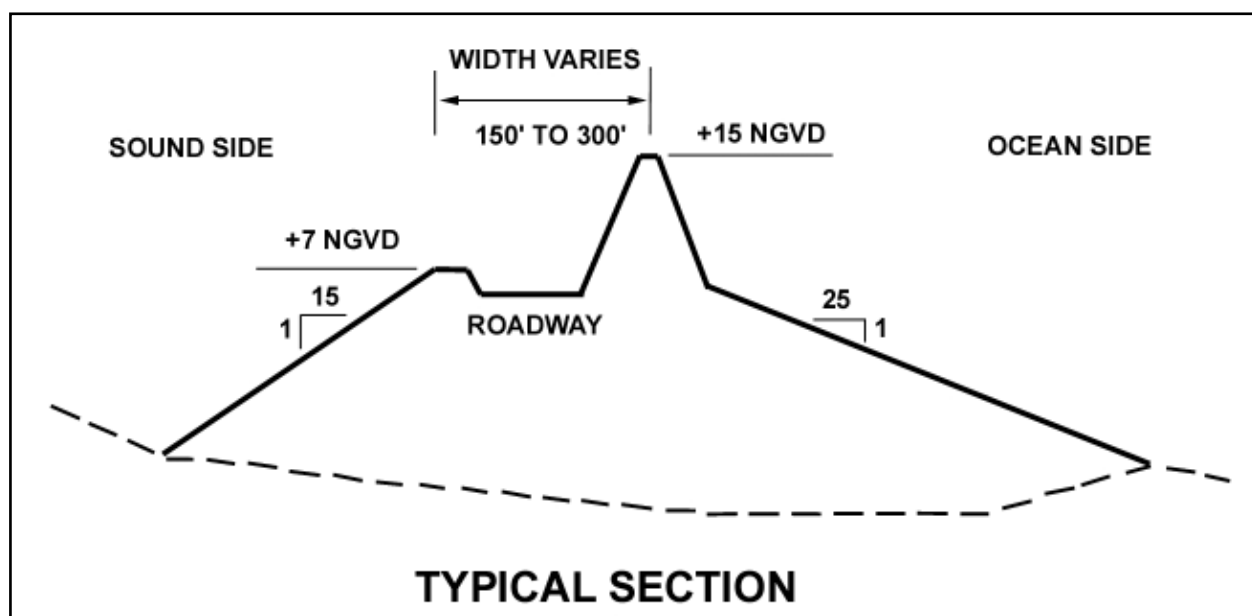
Figure 16. Typical fill cross section.

The design cross section consisted of a berm at elevation +7.0 ft NGVD with a 10-ft-wide dune at +15.0 ft NGVD (Figure 16). The berm and dune elevations were chosen to be consistent with the pre-breach elevations. The pre-breach berm elevation was +6.0 ft NGVD and the average pre-breach dune elevation was +15.0 ft NGVD. Factors influencing the width of the berm were that the berm had to contain enough sand to fill the scour channels formed by the breach, the width of the berm had to be at least 100 ft after waves and currents adjusted the fill profile, and the fill had to transition into the adjacent shoreline. To determine the design berm widths, a design template with a berm width of 100 ft was superimposed on a digital terrain map that was generated from surveys. The volume to construct the design template and fill the scour channels was calculated. Construction berm widths that contain the calculated volume of sand were determined and then the widths were adjusted to transition into the adjacent shorelines. The width of the berm varied from 150 ft in the center breach channel to 300 ft in the main breach channel.

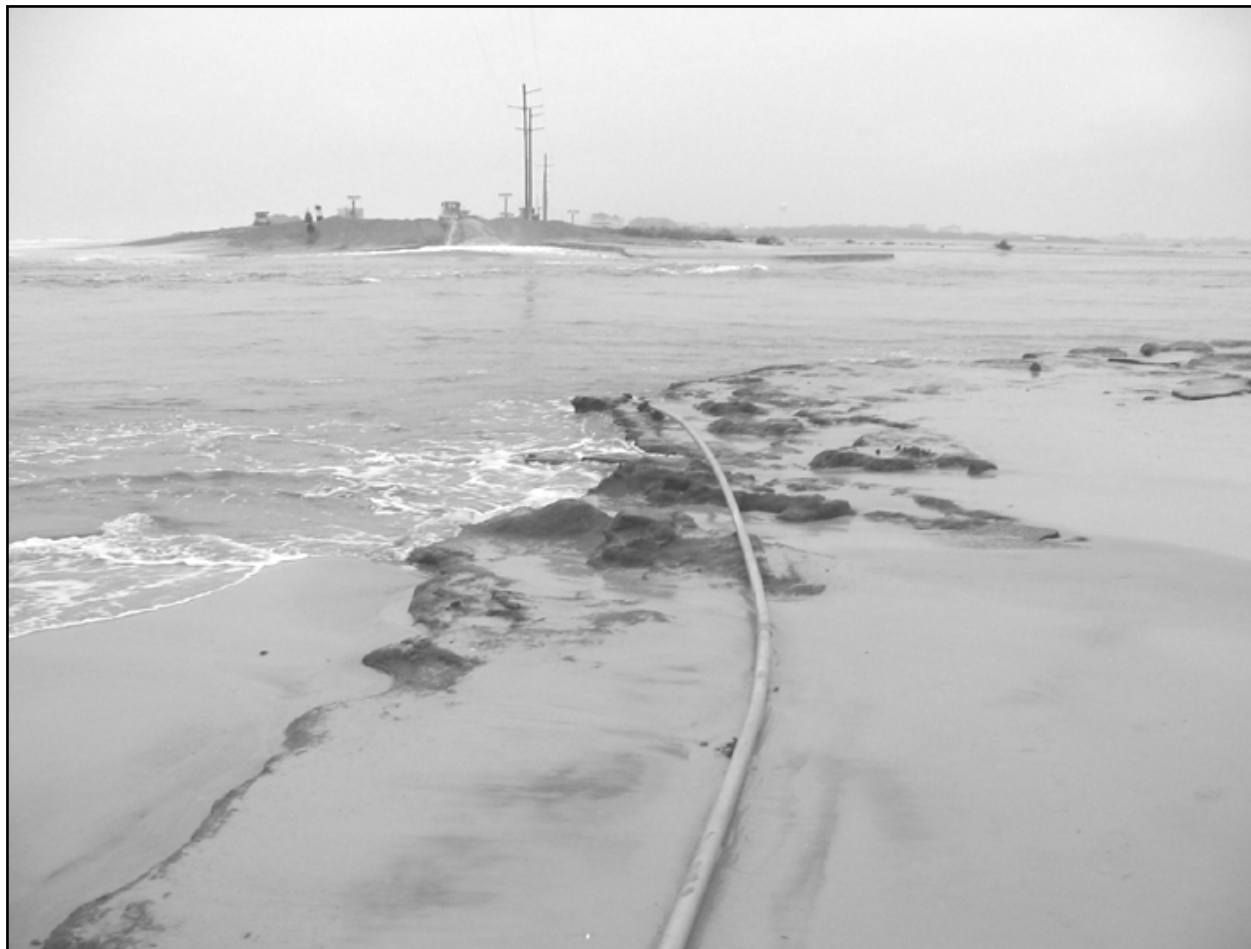
with an erosion resistant peat layer at the eastern bank of the breach allowed the design to omit armoring there. The peat layer was 3 to 4 ft thick, several hundred feet wide, and was exposed at low tide as shown in Figure 17. There was broken asphalt near the high-water line of the east bank of the breach, the peat layer extended 20 ft further into the breach than the broken asphalt and did not appear to erode.

Figure 17. Exposed peat layer on eastern bank of breach.

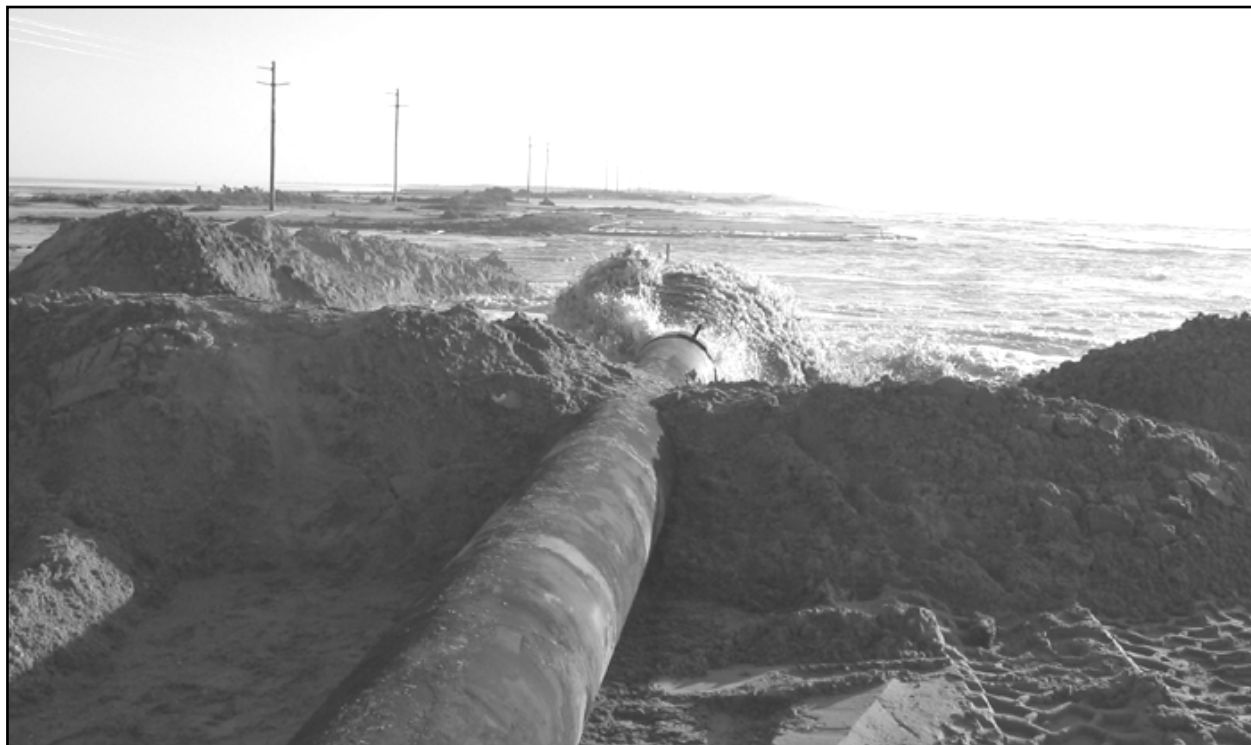
Figure 18. Discharge at western shoulder of breach. View is towards northeast. Island dividing west and center breach channels is in background.

CLOSURE OPERATION: The filling phase of the operation began on 17 October 2003. Two-thirds of the fill width was initially constructed. This shortened the time required to close the breach and reduced the potential for the currents to erode the advancing fill. The discharge pipe outlet was laid on the west bank of the breach along the center alignment of the fill and directed towards the breach. Sand that accumulated at the discharge pipe outlet was shaped by two bulldozers according to the fill template. The sand was never directly discharged into the breach. Sheet flow, created by the discharge from the dredge pipe, carried the sand into the breach (Figure 18). After the design template at the discharge pipe outlet was constructed, additional pipe was laid on the newly filled section and the discharge pipe outlet was advanced. This procedure continued for 15 days. The first two channels of the breach were filled without a noticeable reduction in the rate of advancement of the fill. Three-quarters of the main breach channel was

also filled during this period. The dredge averaged 15 hr/day of pumping time with a production rate of 22,000 cu yd a day. The largest production in a 1-day period was 41,000 cu yd.

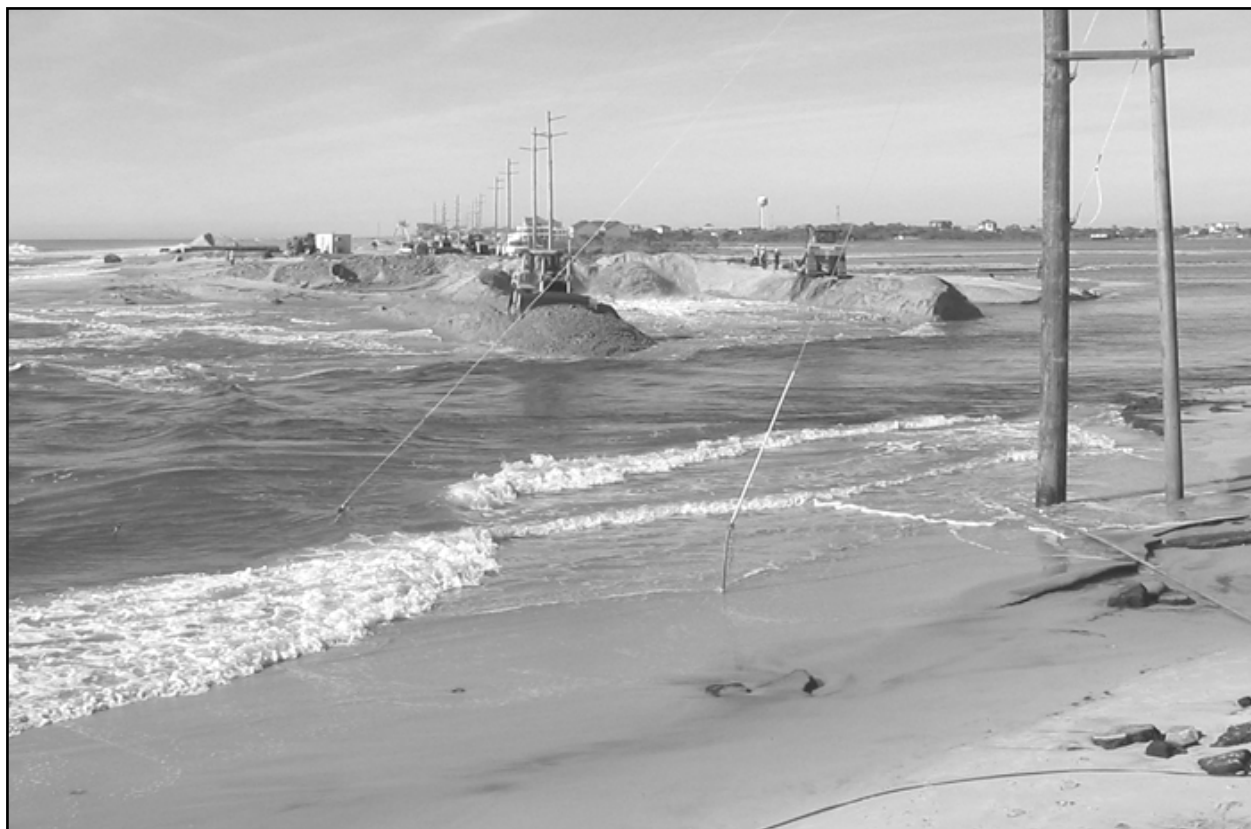
On 1 November 2003, at 9:30 a.m., the tide was low and there was 75 to 100 ft of the breach remaining to be filled. As the cross-sectional area of the breach was reduced, the current velocities increased to the point where much of the sand that was deposited at slack tide was disbursed when the tidal currents strengthened. To facilitate a rapid advance of the fill and close the remaining portion of the breach, the dredging contractor decided to push a narrow mound of sand across the breach at slack tide and stop the water from flowing through the breach. Once the flow of water was stopped, additional material could be added to the narrow mound to fill the remaining design template without the losses caused by the tidal currents. Therefore, the filling procedure was changed from an unconfined discharge, which filled about 150 ft of the design template width, to a new procedure that confined the discharge so that only 20 ft of the design template width was filled. To confine the discharge, two sand dikes about 50 ft apart were constructed on either side of the discharge pipe (Figure 19). The two dikes protected the sand that accumulated at the discharge pipe outlet from erosion due to waves and currents and directed the growing mound across the breach. The distance between the sand dikes needed to be wide enough to allow the bulldozers to maneuver while they pushed the accumulating sand onto the dikes to advance them across the breach. No material was stockpiled in advance of the start of this procedure but the dredge production rate had been as high as 2,300 cu yd of sand in an hour, which provided a sufficient source of sand to build a small dike across the remaining breach.

Figure 19. View of first attempt to complete closure looking to west from eastern bank of breach.

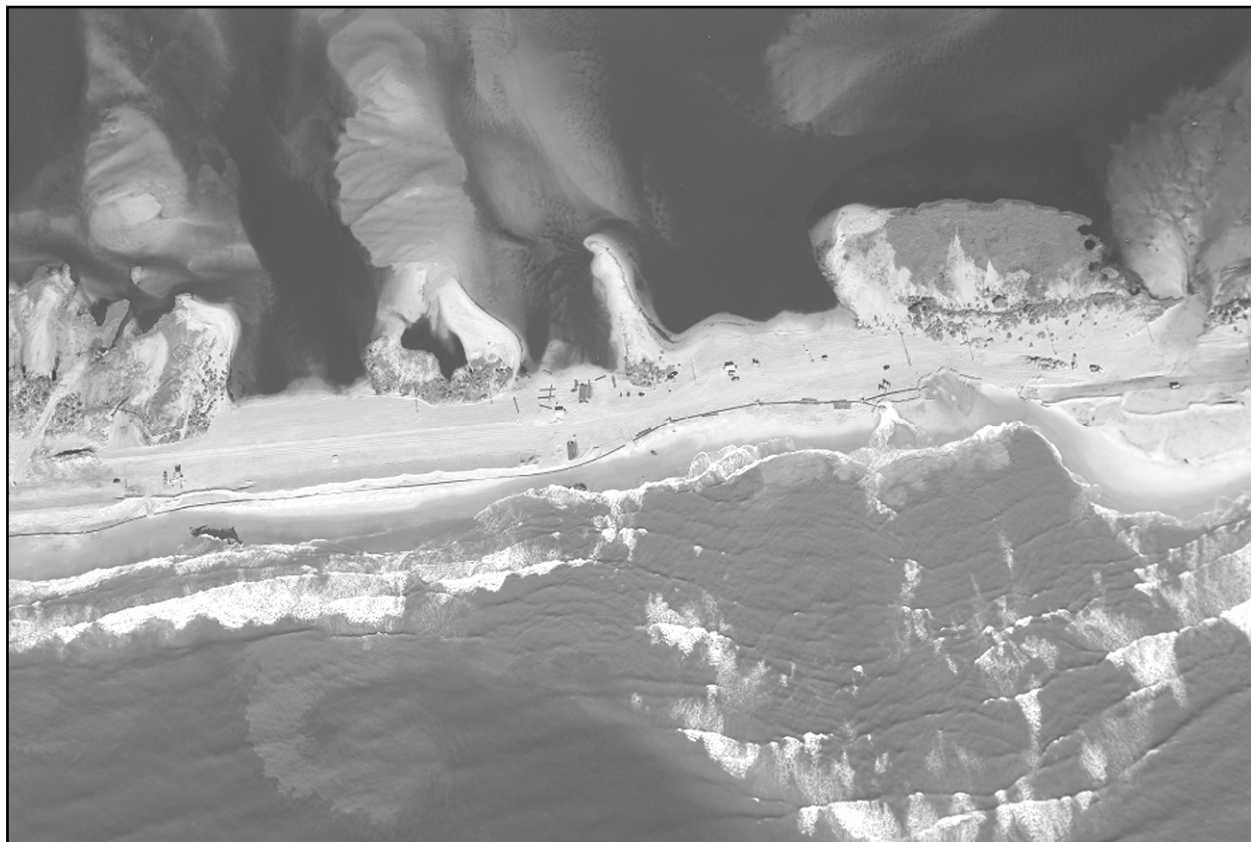
Figure 20. Aerial photo of closed breach on 3 November 2003.

Applying the new procedure, the remaining breach was narrowed to approximately 50 ft in 1.5 hr when at 11:00 a.m. the shaft on the booster failed. The booster was repaired by 4 p.m., but during the 5 hr of inactivity, the dikes, which were as long as 50 ft, were now 10-ft stubs. At 4 p.m., the slack of high tide, another attempt was made to close the breach with the same procedure. At 5:30 p.m., the two dikes were again approximately 50 ft long. This was a sufficient dike length to protect the discharge area from waves and currents and only one of the dikes was extended further to close the breach. As the tide fell and the ebb currents increased through the breach, progress slowed but, at 8:40 p.m., on 1 November 2003, the breach was closed. Throughout the night, the narrow section of the berm was widened to prevent it from breaching during the next high tide. At closure, approximately 300,000 cu yd had been dredged (Figure 20).
